# 6 MAINTENANCE AND PRESERVATION OF CONCRETE STRUCTURES.

Report 2

## REPAIR OF EROSION-DAMAGED STRUCTURES,

11 April 1980

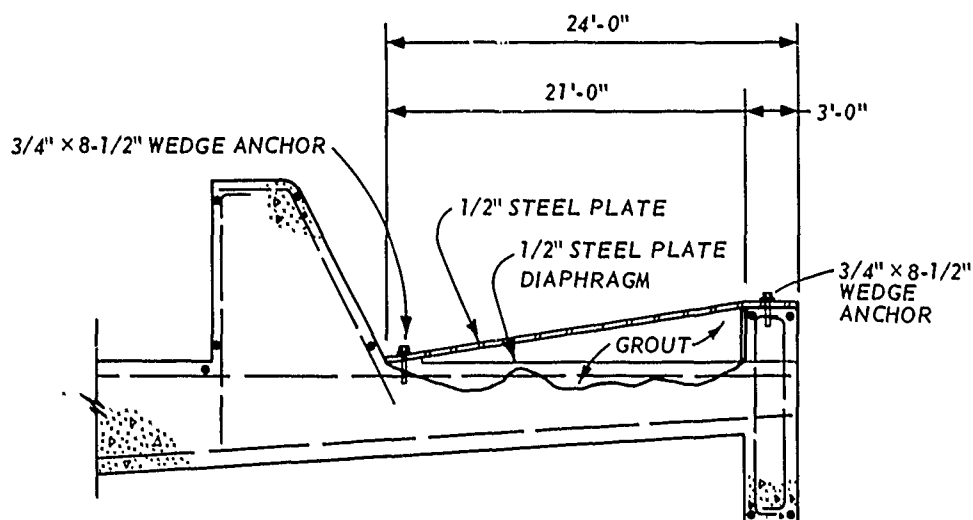
Figure 8. Typical placement of prefabricated module, Old River

the plate and to provide a formed void in which to retain the grout. Modules were prefabricated in New Orleans and were shipped to the job site by barge. The first module installed (No. 12), 6 ft wide and 24 ft long, was placed (Figure 8) behind gate bay 5 in the low bays. The

required number (4) of 8-in.-long expansion anchor bolts was installed to secure the module until it could be grouted. Upon completion of the first day's work, the low bays were opened to allow as much water through the structure as possible because of the extremely low water stages. The following morning, after the low bay gates were closed to allow work to begin, divers inspected the first module. The module was found to be displaced as a result of uplift forces due to flow over the wedge-shaped module. The bolts on the upstream edge of the installed module had been pulled out of the concrete. The nuts on the bolts placed in the end sill wall had worked loose from vibration, thus stripping the threads and allowing the module to lift up. The module was retrieved and found to be in good condition. As a result of this action, it was apparent that gates immediately upstream of an ungrouted module would have to be closed at night to protect the modules until they could be grouted. Modules 13 and 14 were placed next, and the required number of bolts was increased from 4 to 8-16 per module. In some cases, the void beneath the plate along the bolt line was too deep to get enough bolt penetration

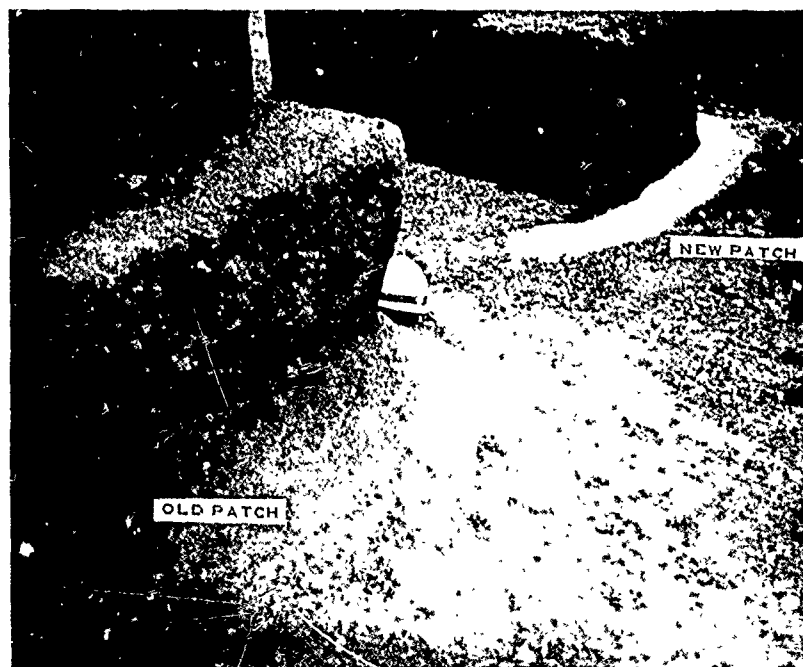
Figure 15. Stilling basin baffles showing old and new concrete patches, Arkabutla

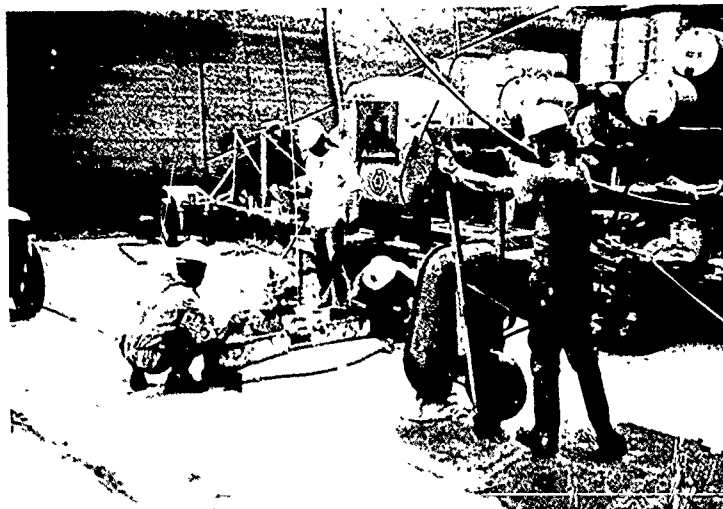
Figure 17. Application of epoxy mortar sealer and wearing course, Arkabutla Dam

laitance and produced a roughened surface. A light prime coat of neat epoxy was applied to the thoroughly cleaned and dried surface and followed by a 1/4-in. epoxy mortar sealer and wearing course (Figure 17). The mortar, consisting of one part epoxy to three parts silica sand, was mixed in a 4.5-cu-ft mortar mixer. The mortar was finished to desired grade with steel trowels. Existing expansion joints were replaced with premolded, sponge rubber joint filler and extended upward to the new surface.

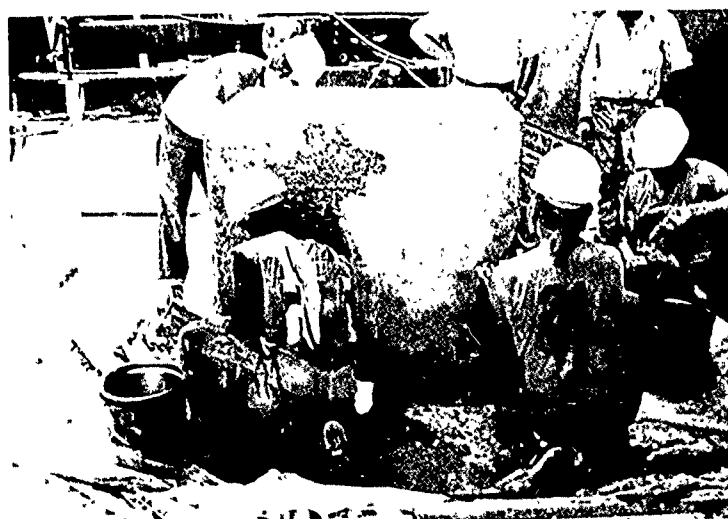
Figure 18. Epoxy mortar repair of baffle, Arkabutla Dam

44. Surface preparation on the baffles was similar to that previously described for the basin floor slabs. Immediately after application of the epoxy bonding material, epoxy mortar was hand-trowelled onto uneroded areas of the baffles (Figure 18) to a minimum thickness of 1/4 in. On eroded areas, the thickness of coating was that necessary to restore the baffles to their original dimensions.

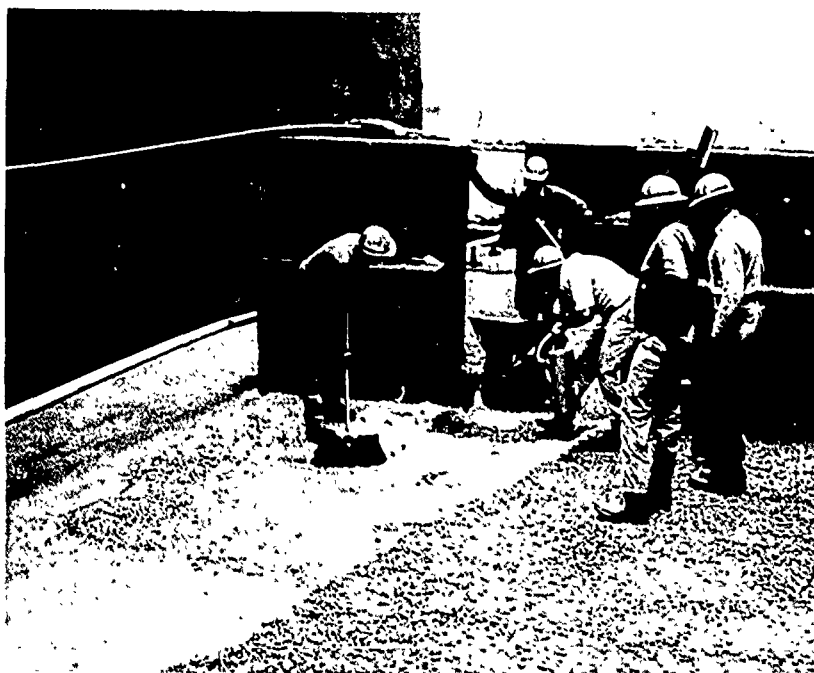
Figure 21. Temporary repairs to stilling basin,  
Enid Dam

50. Areas of most advanced erosion were repaired (Figure 21) at the time of the 1968 inspection with a temporary protective coating. The material and method of application was the same as previously described for the Arkabutla stilling basin. Although erosion on the steps was not as extensive as that on the stilling basin floor, two test patches were made on the seventh step, el 192, in both the north and south passages. These patches were exposed each time the gates were closed so that durability could be monitored.

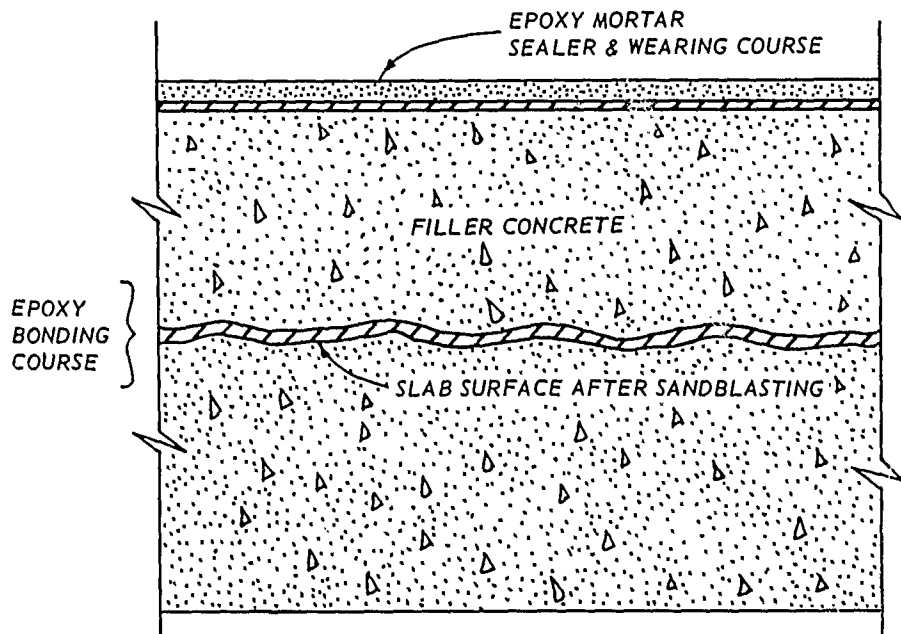
Figure 23. Stilling basin slab repair, Enid Dam

53. In 1976, permanent repairs were made to the stilling basin floor slab and baffles. This work was accomplished under the same contract with essentially the same materials and techniques previously described for Arkabutla. The stilling basin slab was restored to original grade with an epoxy-bonded unreinforced concrete overlay (approximately 93 cu yd) and epoxy mortar sealer and wearing course (Figure 23). Strength gain characteristics of the filler concrete are shown in

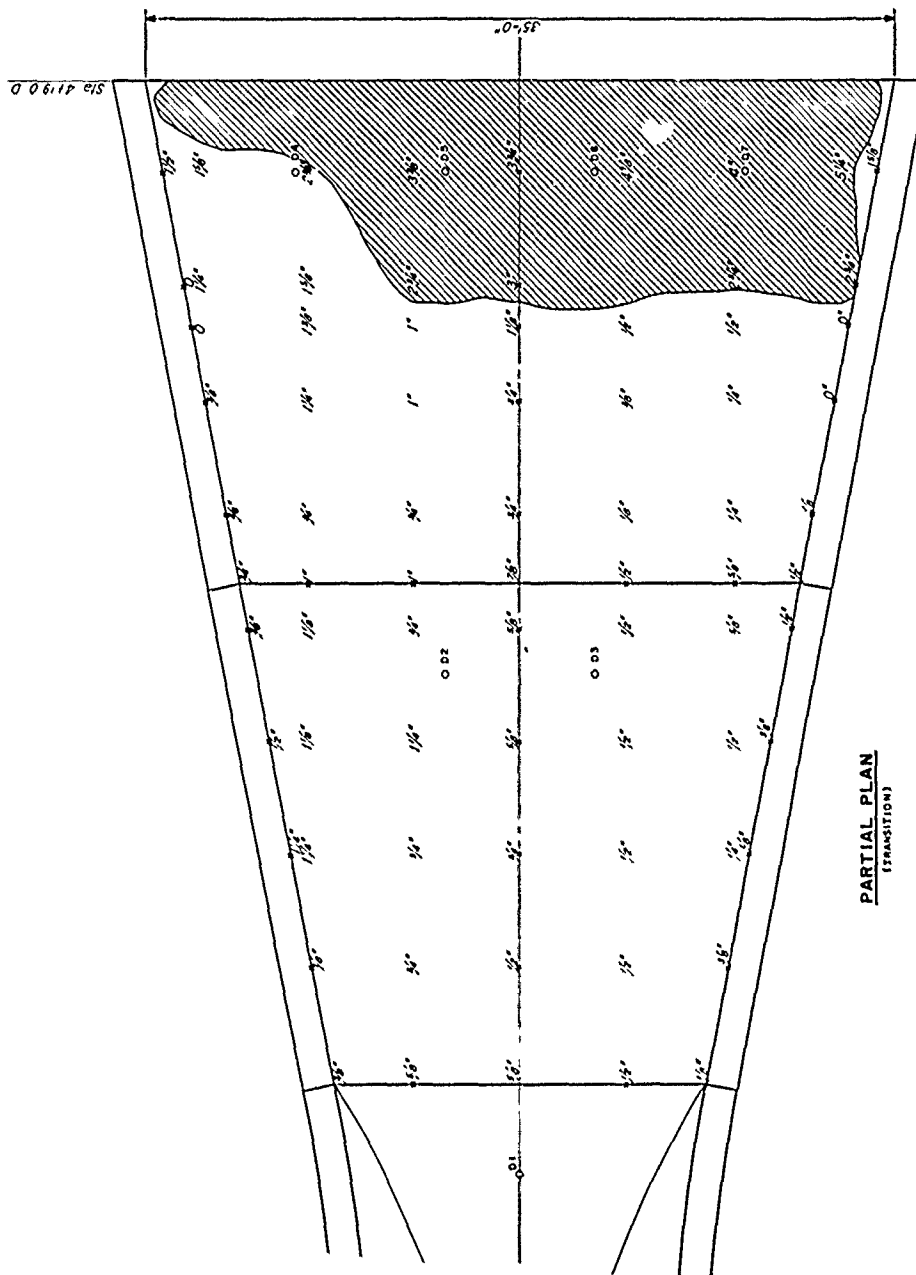
70. The basin was dewatered for inspection and repair in October 1972. Additional erosion was observed; however, the rate of erosion appeared to be less. The reduced rate of erosion was attributed to a decrease in the number of days with discharges above 500 cfs. The erosion observed before the repair is shown in Figures 33 and 34.

Figure 33. Transition erosion, Pomona Dam

requirements were fulfilled by pumping lake water through the spillway. The pumping was accomplished by Corps of Engineers field personnel. The repair, including dewatering, debris removal, and the control of leakage, seepage, and surface drainage, was accomplished by contract. The repair included (a) a 1/2-in. minimum thickness epoxy mortar applied to approximately one half of the transition slab; (b) an epoxy mortar applied to the upstream face of the right three upstream baffles; (c) a 2-ft-thick concrete overlay slab placed on the upstream 70 percent of the basin slab; and (d) a sloped concrete face added to the end sill.

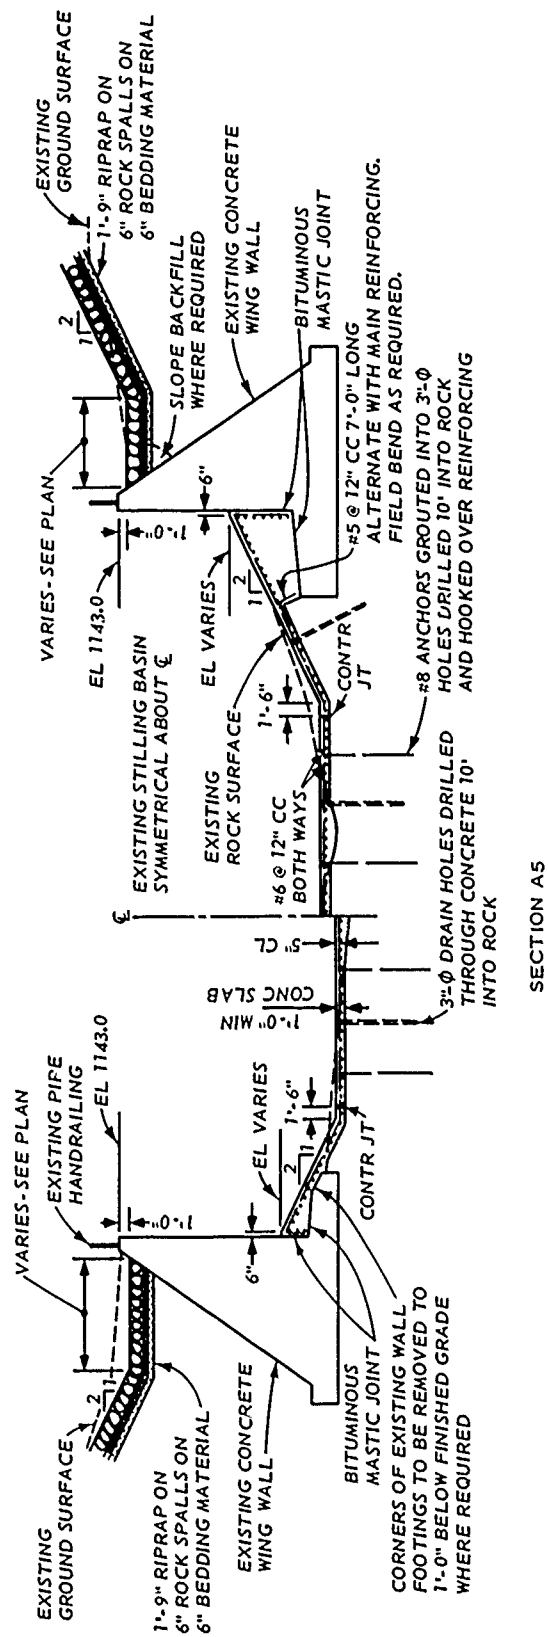
Figure 43. Section A5, concrete paving details, Curwensville Lake

erosion downstream in the river channel were such that repairs were deemed necessary. Channel improvements consisted of dewatering the stilling basin down to the existing end sill and putting in a new concrete apron, in addition to excavating the outlet channel and placing riprap along both banks. The reinforced concrete apron has a minimum thickness of 12 in. and design compressive strength of 3000 psi. The apron slab slopes upward from the end sill of the stilling basin one vertical to five horizontal and flares from a width of 39 ft of the end sill to 60 ft at a distance of 59 ft downstream. Side slopes from the apron to the wing walls were also paved. Concrete paving details are shown in Figures 42 through 44. Photographs taken during the construction operations are shown in Figures 45 and 46. Estimated quantities of concrete paving and riprap were 450 and 13,500 cu yd, respectively. The contract bid was \$723,365 and work was completed in 1974.

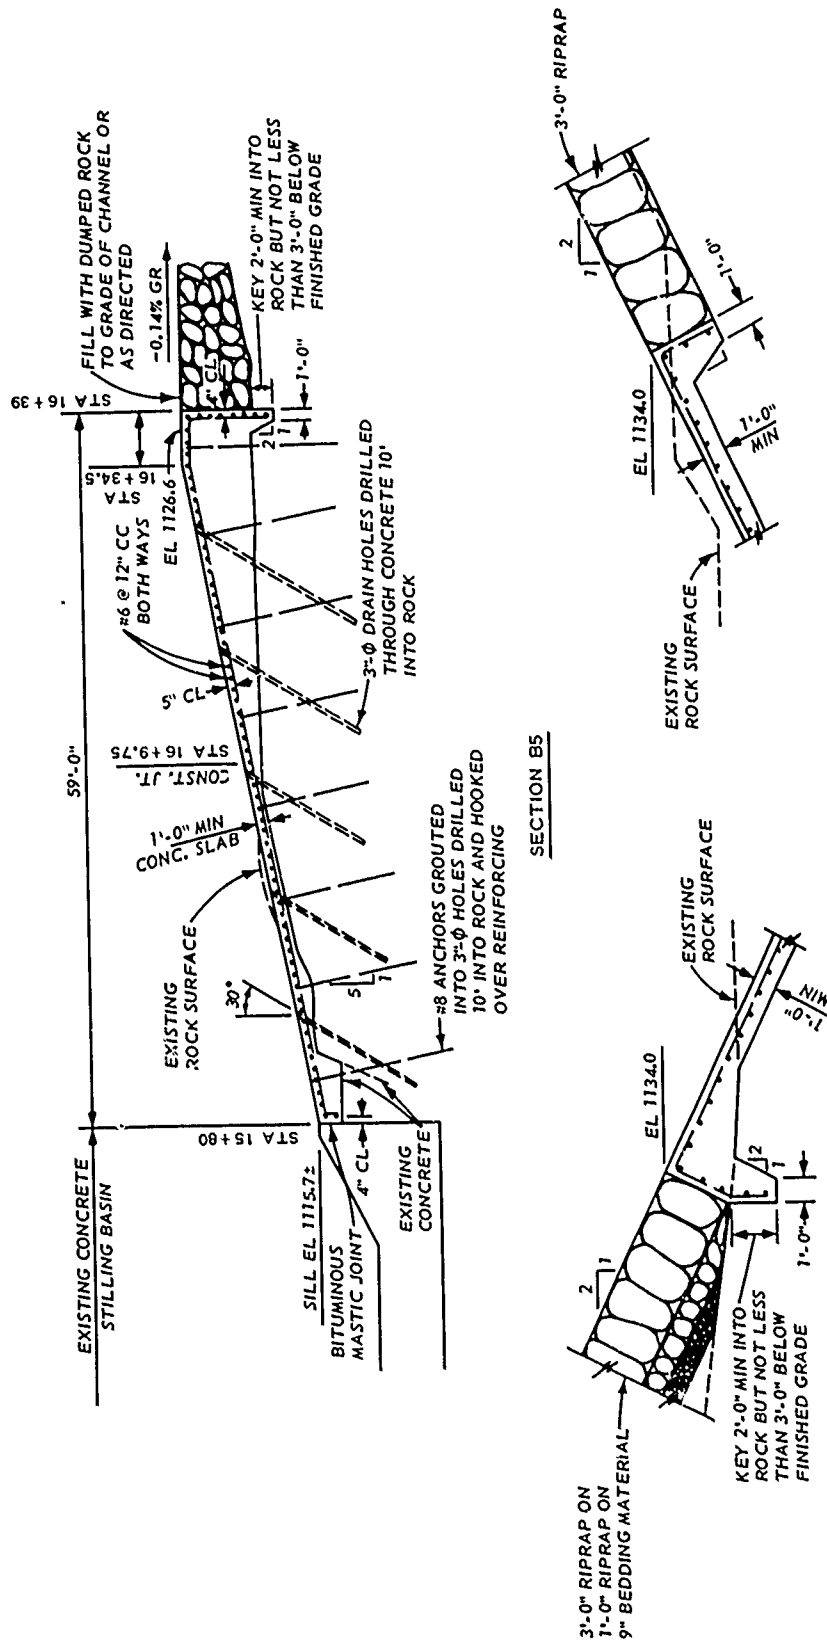
Figure 44. Sections B5, C5, and D5, concrete paving details, Curwensville Lake

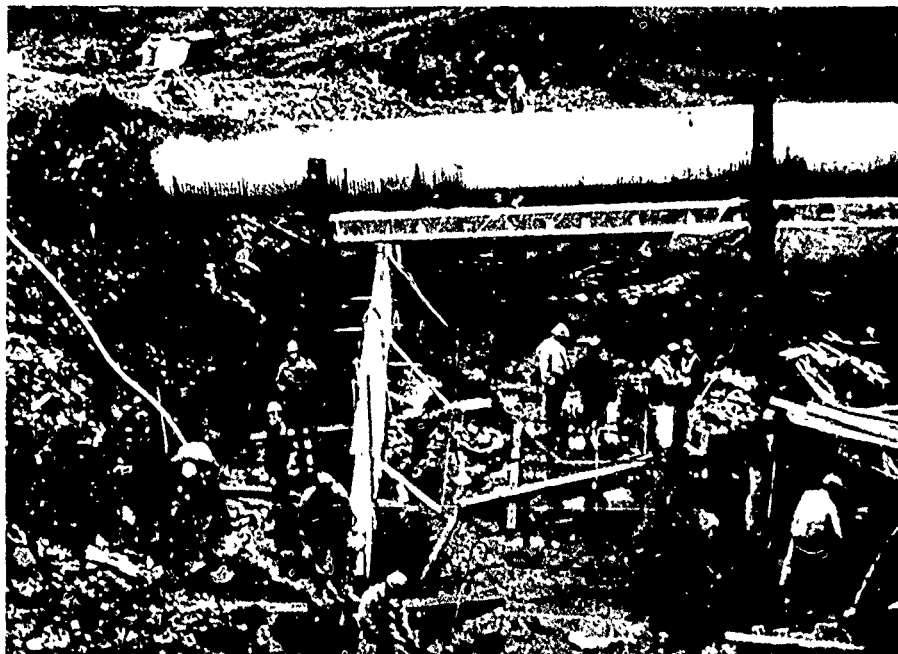
Figure 46. Preparation for placement of reinforced concrete slab

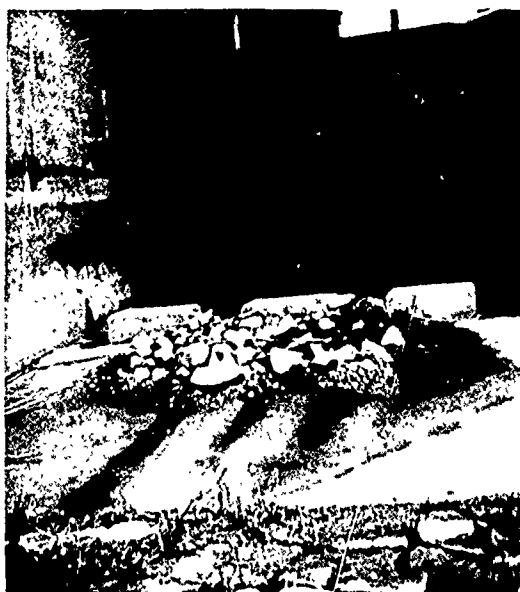
98. After the cofferdams were constructed and the structure was dewatered, representatives of the U. S. Army Engineer District, St. Paul, inspected the structure (St. Paul District 1974) to determine the exact extent of repair required. At the time of the inspection, all bays of the control structure, except bay 12, were dewatered, allowing for a thorough inspection of each bay. Several areas of concrete deterioration (Figure 49) were found in the piers, generally along the waterline in each bay. Several base slabs exhibited severe wear and exposed reinforcement. The most severe erosion was in bay 2 (Figure 50) where there was a hole about 1 ft in diameter and 2 ft deep caused by rocks trapped between the gates and weir. Other examples of the concrete deterioration are shown in Figure 51.

a. Erosion between baffle of wall

b. Miscellaneous debris

c. Baffle deterioration

Figure 51. Examples of concrete deterioration, Lac Qui Parle Dam  
(from St. Paul District 1974)

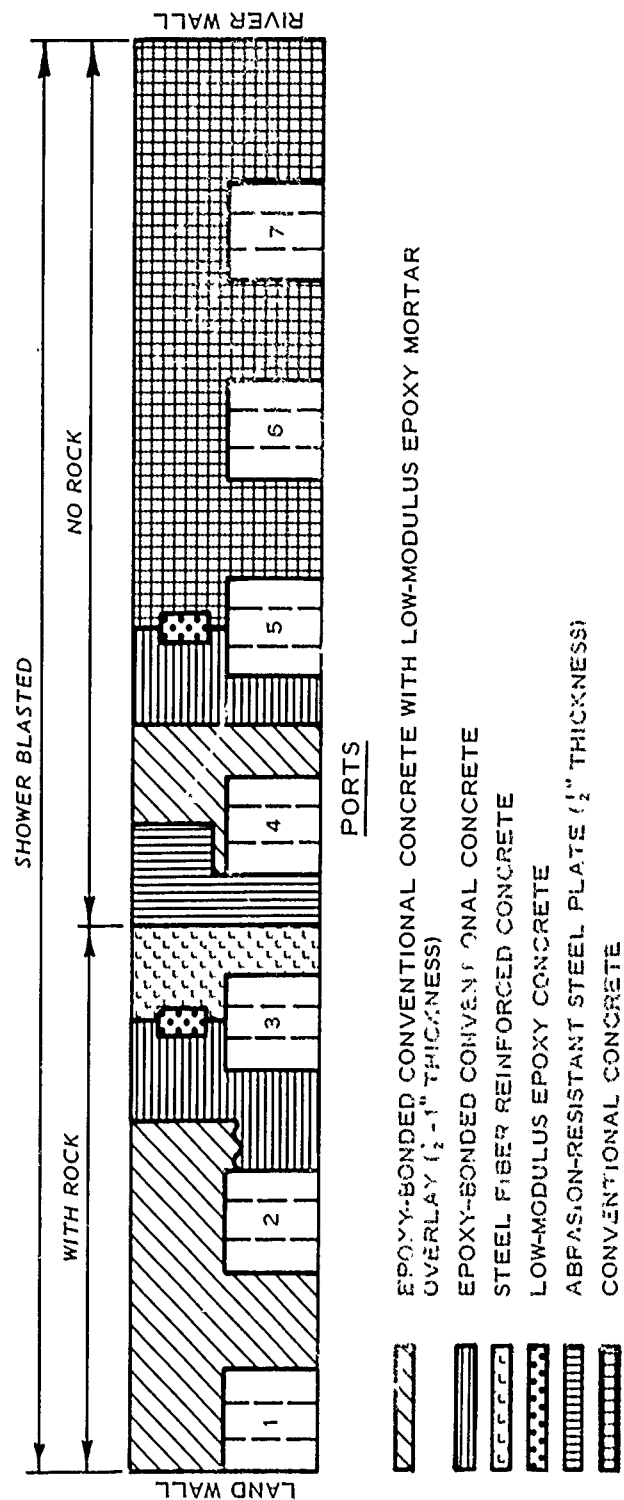
Figure 61. Experimental lateral (bay H), Upper St. Anthony Falls Lock

- a. Epoxy mortar. A low-modulus epoxy mortar, 1/2- to 1-in. thickness, was to be used to overlay two sections of conventional concrete (Figure 61). Concrete to receive the overlay was left approximately 1 in. below grade. The mortar consisted of one part epoxy to three parts silica sand. Conditions during the repair were described as fair to poor with too much standing water to do a good job.

- e. Steel plate. One section of an abrasion-resistant steel plate (1/2-in. thickness) was anchored to conventional concrete. After completion of repairs and prior to filling the lock chamber, rocks that caused the erosion damage were returned to their original positions in the lateral (Figure 61) to provide a positive test of the repairs.

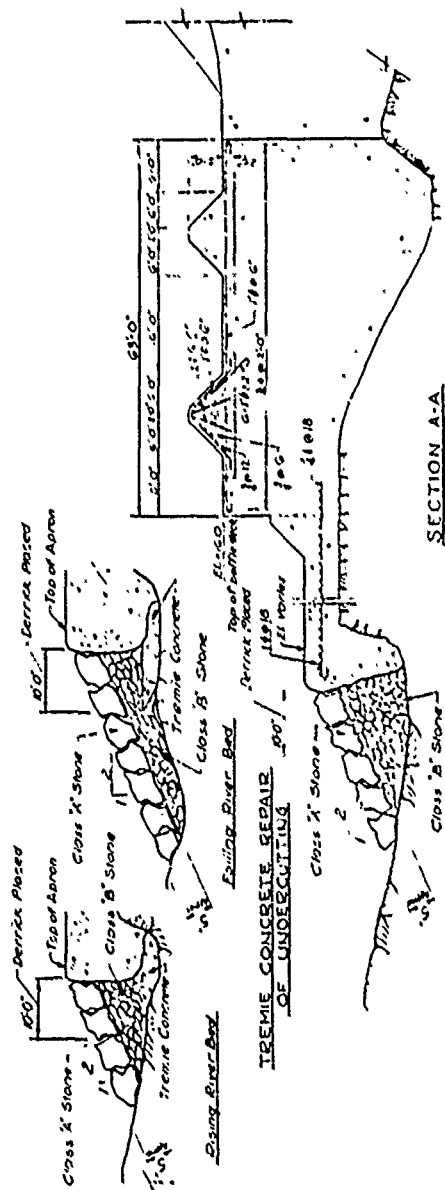
Figure 70. Apron and baffle repair, Bonneville Dam

118. Details of the apron and baffle repairs are shown in Figures 70 and 71. The upstream row of baffles was reconstructed whereas the downstream row was covered by the new end sill. The baffle deck was repaired by anchoring a reinforced concrete slab (12-in. minimum thickness) over the existing deck.

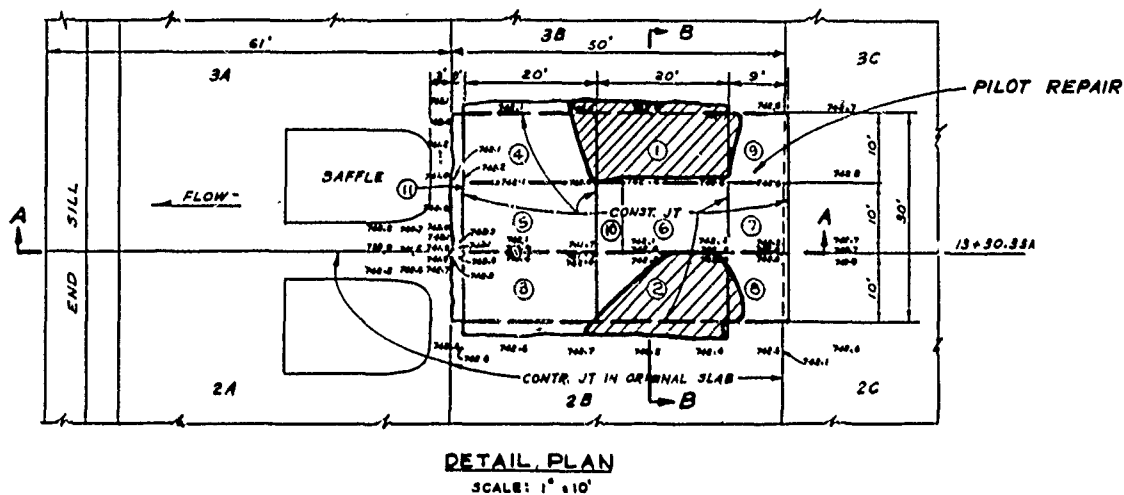
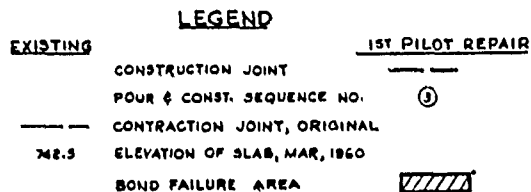
136. Although parts of the slab were found to be damaged (Figure 75), the major portion of the slab was in excellent condition. A large part of sections 1 and 2, which are each 10 by 20 ft, was gone. The original concrete surface was exposed, indicating a bond failure of repair concrete to original concrete. The bond failure is attributable to several factors. Considerable difficulty was encountered when the side forms were removed from sections 1 and 2. An excessive amount of

Figure 75. November 1961 inspection of pilot repair, Chief Joseph Dam (from Seattle District 1962)

grout was intruded into the two sections and flowed over the top and along the outside of the forms. This overflow caused the side forms to be concreted in and necessitated the use of 15-ton capacity railroad jacks to remove them. The force used to lift the side form pieces out of the concrete could have been sufficient to break the bond between the freshly placed repair concrete and the original concrete. In later sections, the divers used extreme care to avoid overtopping the side forms. This precaution permitted forms to be removed with relative ease.

137. A secondary cause of failure may have been the lesser degree of fluidity of grout in the first two sections than in succeeding pours. Flow cone measurements of grout in sections 1 and 2 varied from 21 to 24 seconds while the flow cone measurements of most of the remaining sections varied from 19 to 20 seconds. The greater degree of fluidity in the later sections may have improved the intrusion flow around and

138. Small parts of sections 4, 8, 9, and 11 lying adjacent to the first two sections were torn out due to the failure in sections 1 and 2. The upstream edges of the transition sections 7, 8, and 9 were in good condition. The upstream feather edges of transition sections 7 and 9 resisted stilling basin currents as did the edge of section 8, which was placed in a 4- to 6-in. slot cut into the eroded concrete. A small part of the surface of section 8 had coarse aggregate in relief at the time of completion of repair work due to lack of grout. This area has eroded several inches since placement. The surfaces of all other sections remaining in the repair slab exhibited no signs of erosion.

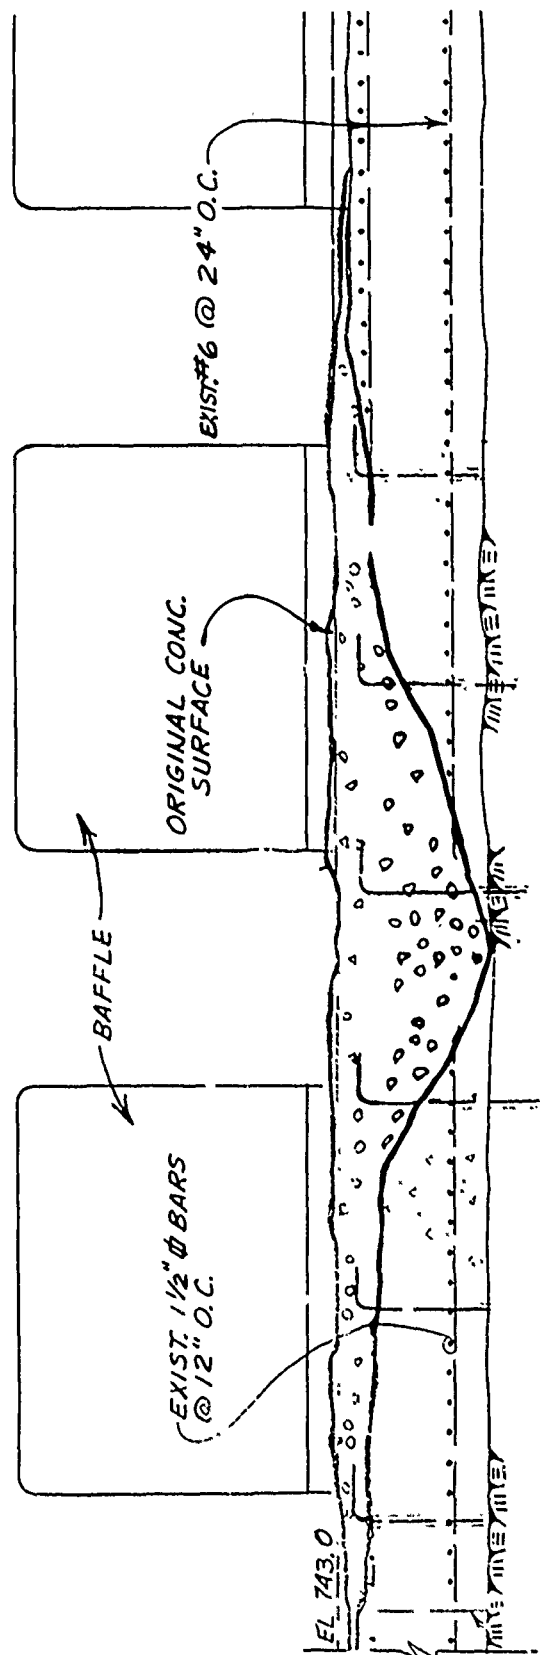
Figure 80. Typical transverse section, blocks 10A and 11A, Chief Joseph Dam

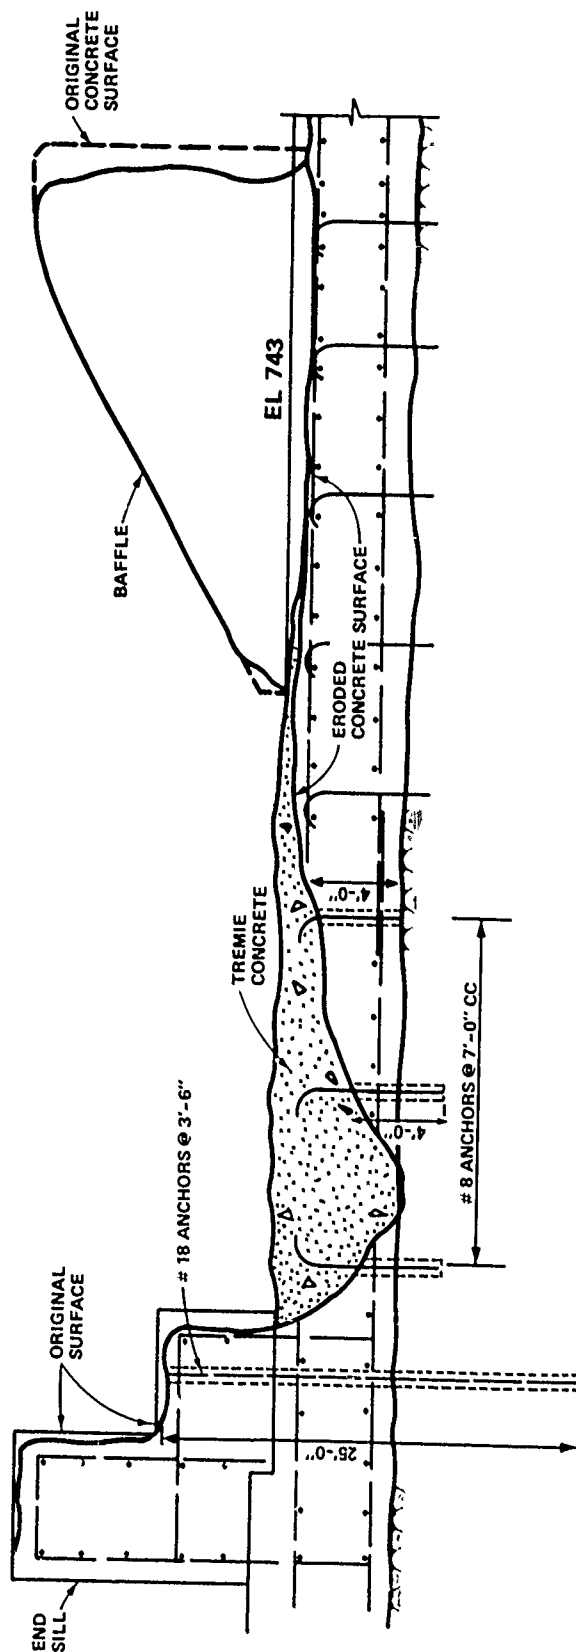
Figure 81. Typical longitudinal section, block 10A, Chief Joseph Dam

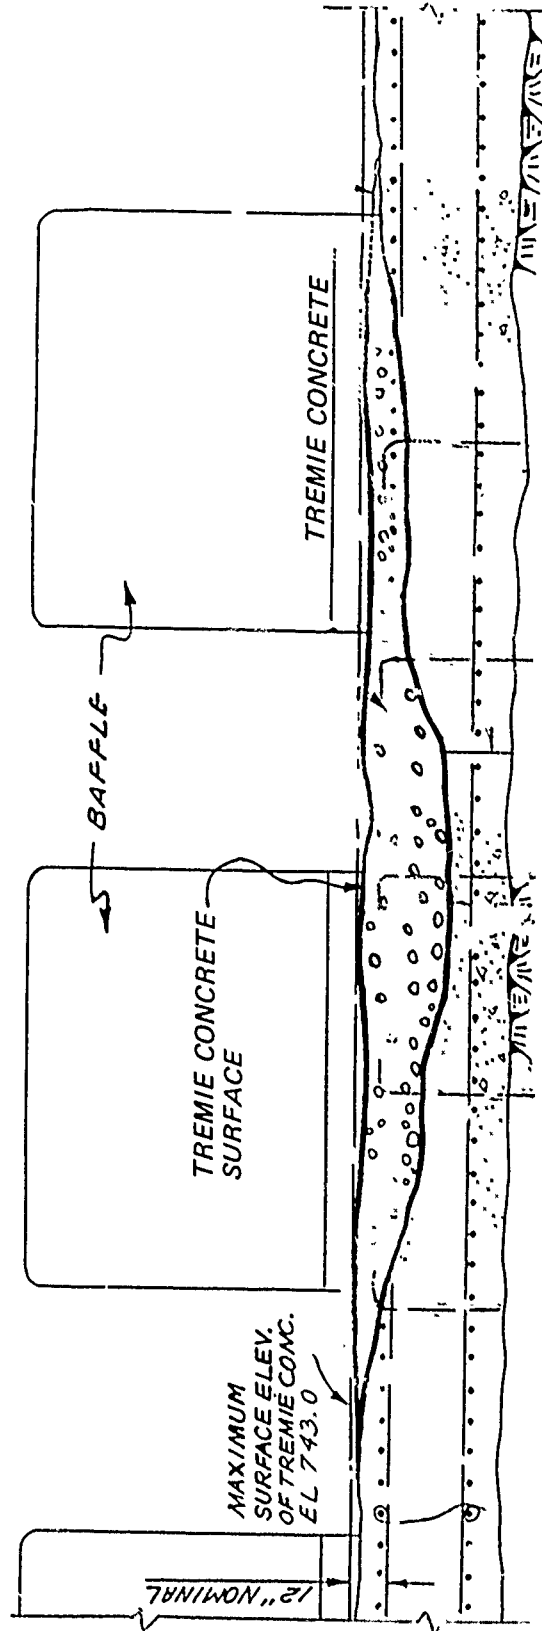
Figure 83. Typical transverse section, block 12A, Chief Joseph Dam

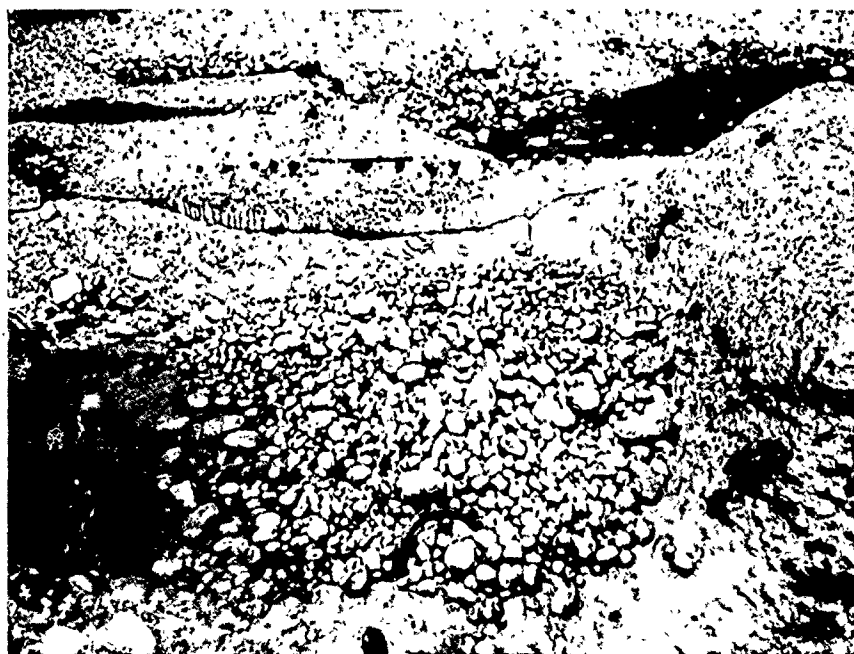
Figure 96. Stilling basin debris, Libby Dam

a. Reinforcing steel and other miscellaneous debris

b. Cobbles

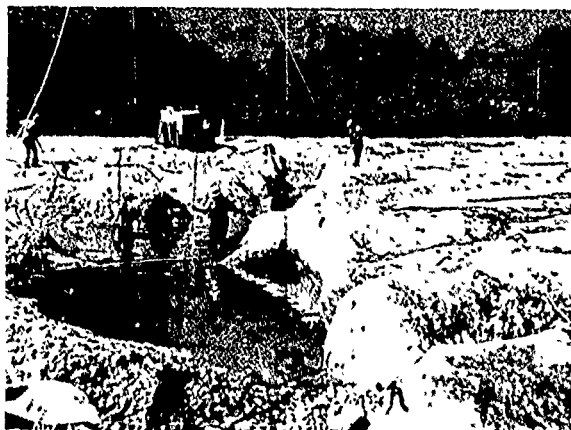
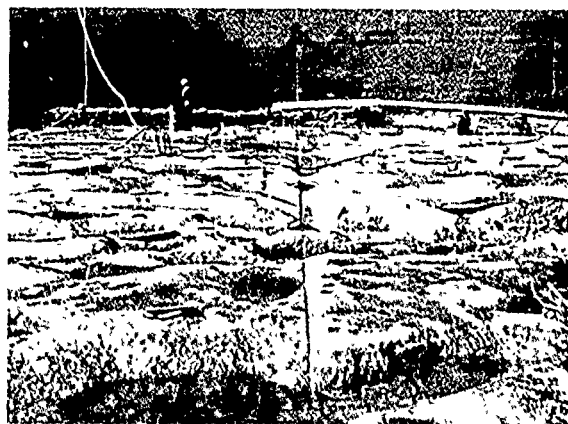
Figure 112. Erosion damage, Dworshak Dam  
(from Walla Walla District 1975a)

worn surface. The majority of the stilling basin floor received some degree of severe damage (Figures 111 and 112). At the deepest point (approximately 10 ft), erosion had progressed completely through the concrete and into the granite bedrock. Apparently, erosion of the stilling basin floor started at the joints in the slab. All 1049 uplift pressure drainholes placed during original construction were plugged with gravel, nails, reinforcing bar ends, and miscellaneous debris.

a. Maximum erosion,  
Station 41 + 65

b. Erosion at  
Station 40 + 50

c. General stilling basin  
erosion

d. Typical wall erosion

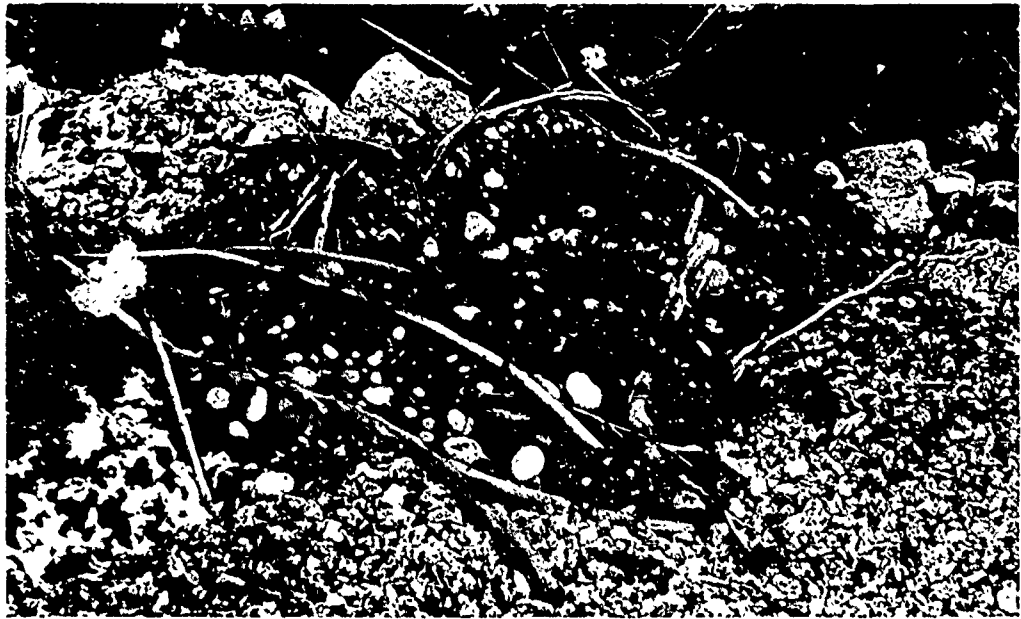
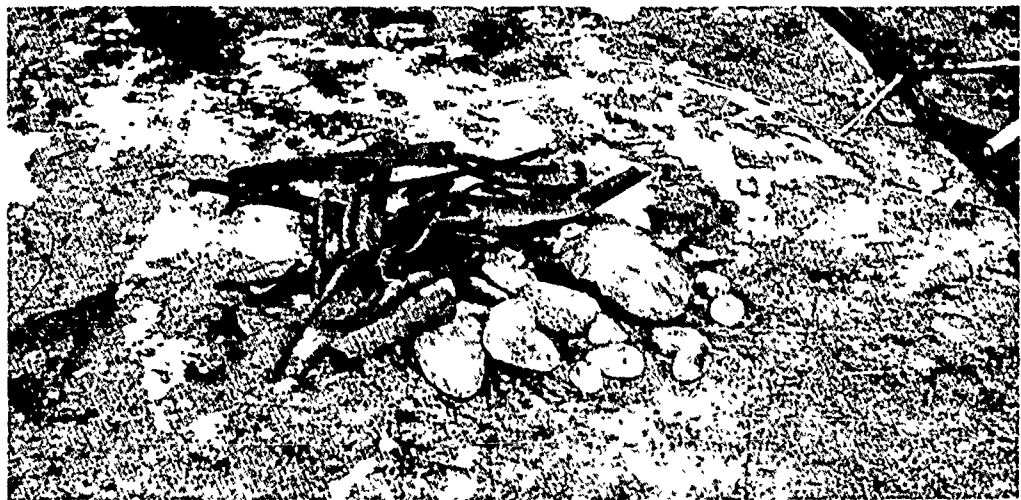
Figure 118. Typical debris removed from stilling basin during Nov 1976 cleaning, Dworshak Dam (from Walla Walla District 1977)

a. General gravel and non-metallic debris

b. Metallic debris and cobbles

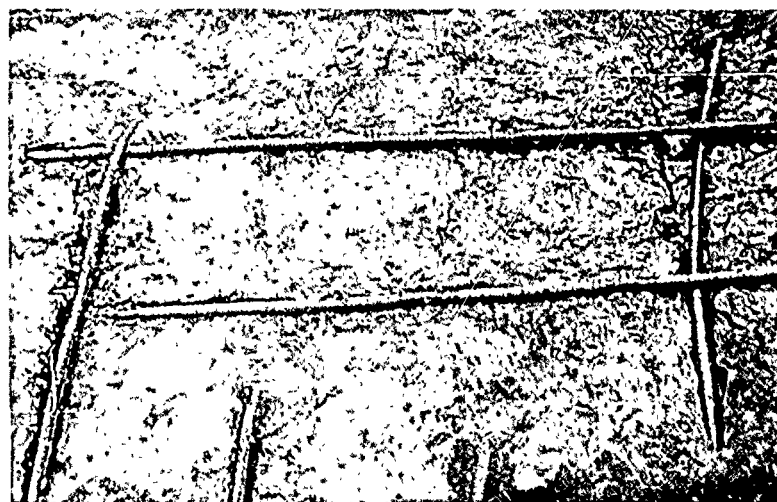
227. The top layer of reinforcing steel was exposed on the lower portion of the parabolic section (Figure 125) and on the lower downstream portion of the baffles (Figure 124). The top reinforcement steel was missing in the middle portion of the stilling basin floor between the parabolic section and the baffles and also at the holes in the downstream corners of the stilling basin. Elsewhere, the stilling basin floor top reinforcement steel was in place, but exposed. At the end sill, the top reinforcement steel was either exposed or missing. Several feet of wall reinforcement steel were also exposed adjacent to the holes in the downstream corners of the stilling basin. After the inspection, Operations personnel removed the rocks and loose reinforcement (Figure 126) and returned the stilling basin to service until repair work could be scheduled.

Figure 125. Typical erosion of parabolic section, Nolin Dam

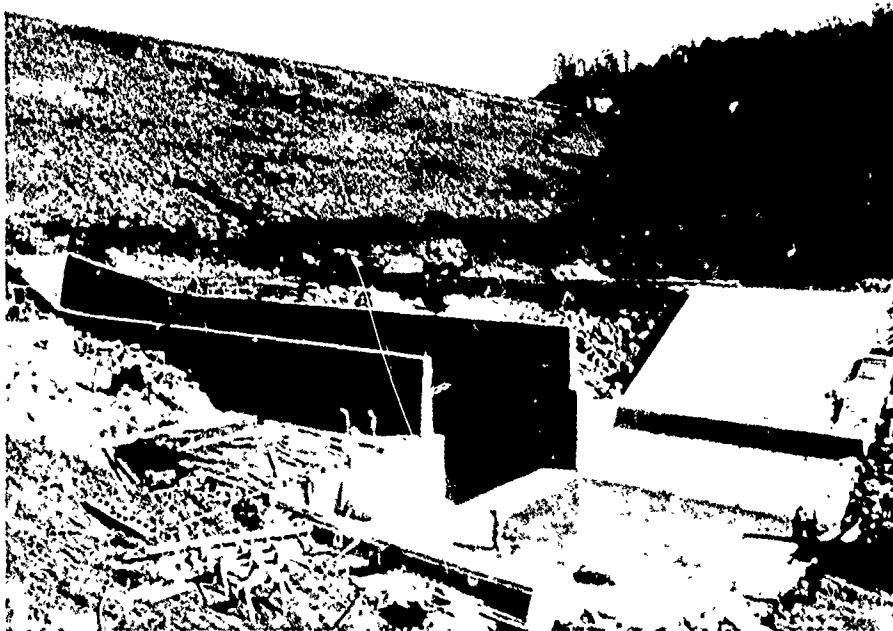
Figure 130. Stilling basin end walls, channel lining and equipment pad, Nolin Dam

230. The new stilling basin end walls (Figure 129) are gravity walls, the top of which will support a removable closure beam at the stilling basin walls. Dowels were used to tie a portion of the concrete paved channel section (Figure 130) to the underlying rock. Where it was not practical to tie the concrete-paved channel section to the underlying rock, a thickened concrete section was placed. A fishing platform was provided on the slope of the paved channel section. The concrete pad adjacent to the right stilling basin wall will permit a mobile crane to place a closure at the end of the stilling basin wall

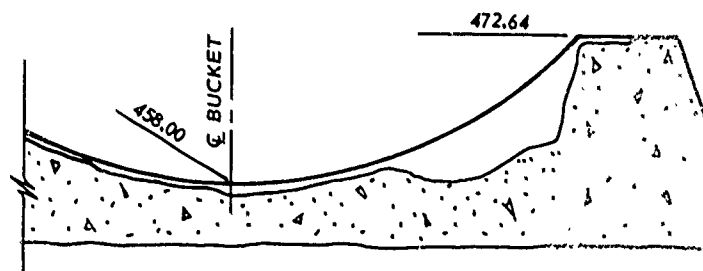
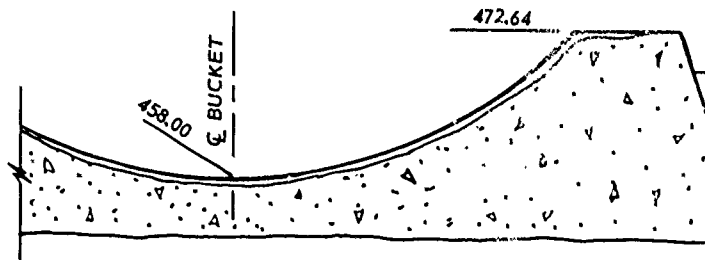
consisted of a cavity of approximately 107 cu yd in volume, beginning near the bottom corner of sluice 1 and increasing in depth and width to a point nearly one third through the bucket lip (Figures 133 and 134). A cross section generally typical of the wear throughout the remainder of the right bucket section is also shown in Figure 134. The wear on the other two bucket sections was slightly less than this particular cross section. The approximate plan location of a pile of aggregate consisting of sand, river gravel, and stone in an estimated quantity of 64 cu yd is shown in Figure 134. The aggregate deposit was analyzed and it was determined that the stone and gravel were washed from the arm of the cofferdam tying into the high bucket section.

- a. The erosion at the sluice outlets was the result of the combined action of cavitation and impact of large boulders being moved about by the swirling action of the water in the bucket. It was agreed that the design of the sluice outlets could have been improved by using rounded or splayed corners instead of square ones.

Figure 134. Extent and location of erosion damage, Center Hill Dam

242. The concrete surrounding the large cavity in the right bucket section was chipped down 1 ft below the existing elevation in the pattern outlined in Figure 134. Vertical 1-in. square steel dowels on 4-ft centers were grouted 40 in. into the existing concrete. The ends of the dowels were split and driven onto wedges to provide anchorages before being grouted. A horizontal steel mat consisting of 3/4-in.-diameter bars on 18-in. centers both ways was fastened to the vertical dowels (Figure 135). This steel received a minimum 3-in. cover of new concrete. The concrete consisted of 1-1/2-in. MSA with 517 lb of cement per cu yd. A total of approximately 178 cu yd of concrete was required to fill the cavities and other damaged areas after chipping operations in preparing them for concrete.

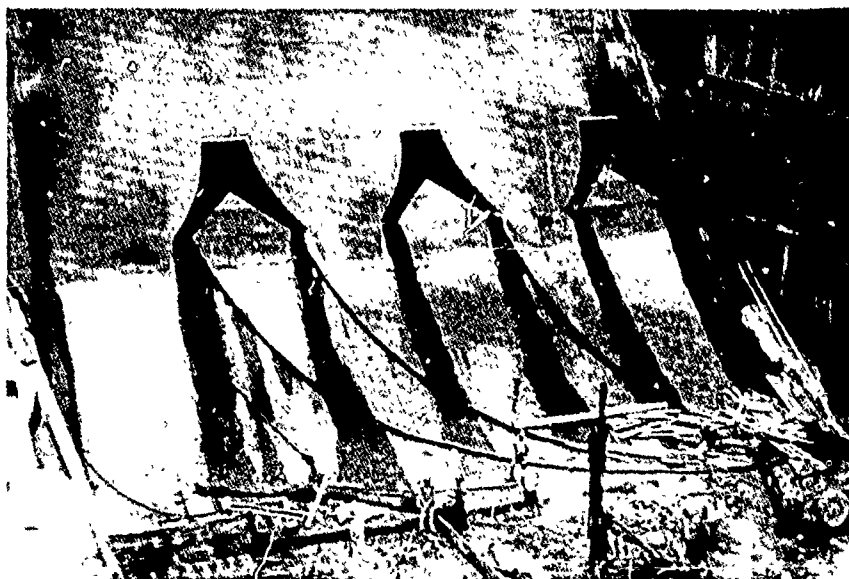
Figure 141. Concrete removal and anchor installation, Kinzua Dam

254. In preparation for the repair, the floor of the stilling basin was cleaned by wet sandblasting. Loose, weak, or deteriorated concrete was removed by chipping (Figure 141). All loose materials and impurities were then removed by washing or wet sandblasting, and No. 8 dowels were installed on approximately 3-ft centers (Figures 142 through 144). The deeper holes were partly filled with dense concrete having a 28-day compressive strength of 3000 psi.

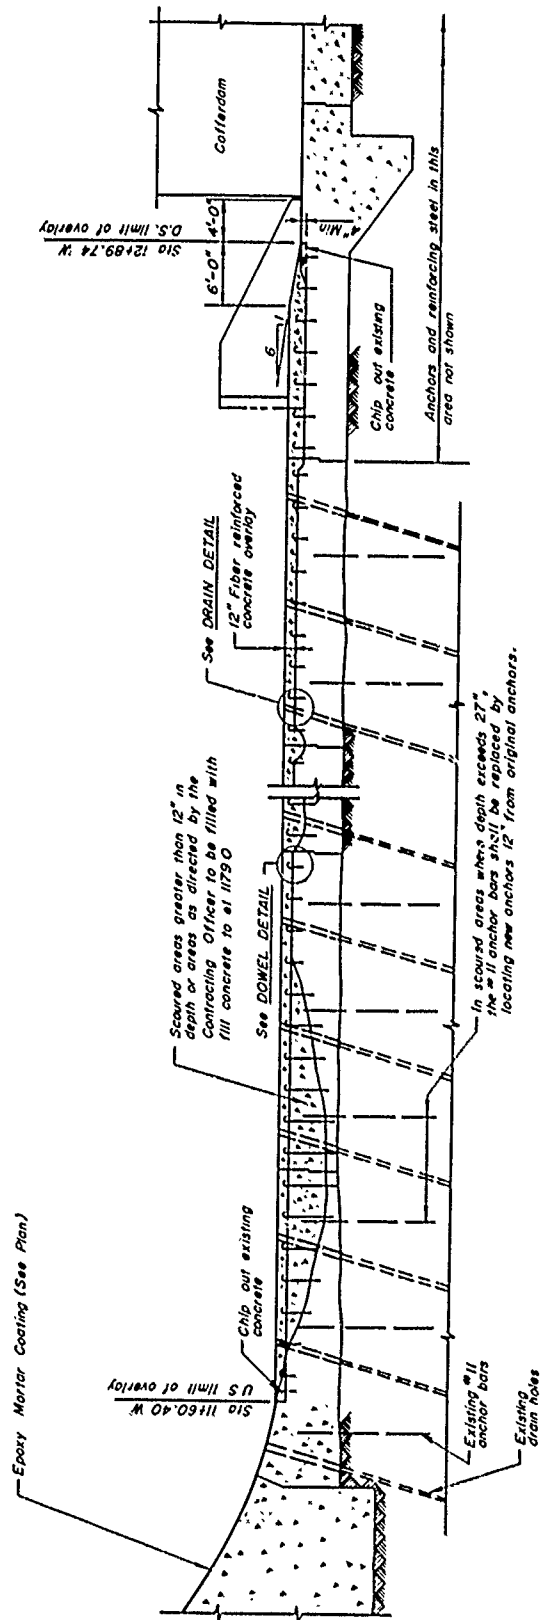
Figure 143. Section, stilling basin repairs, Kinzua Dam

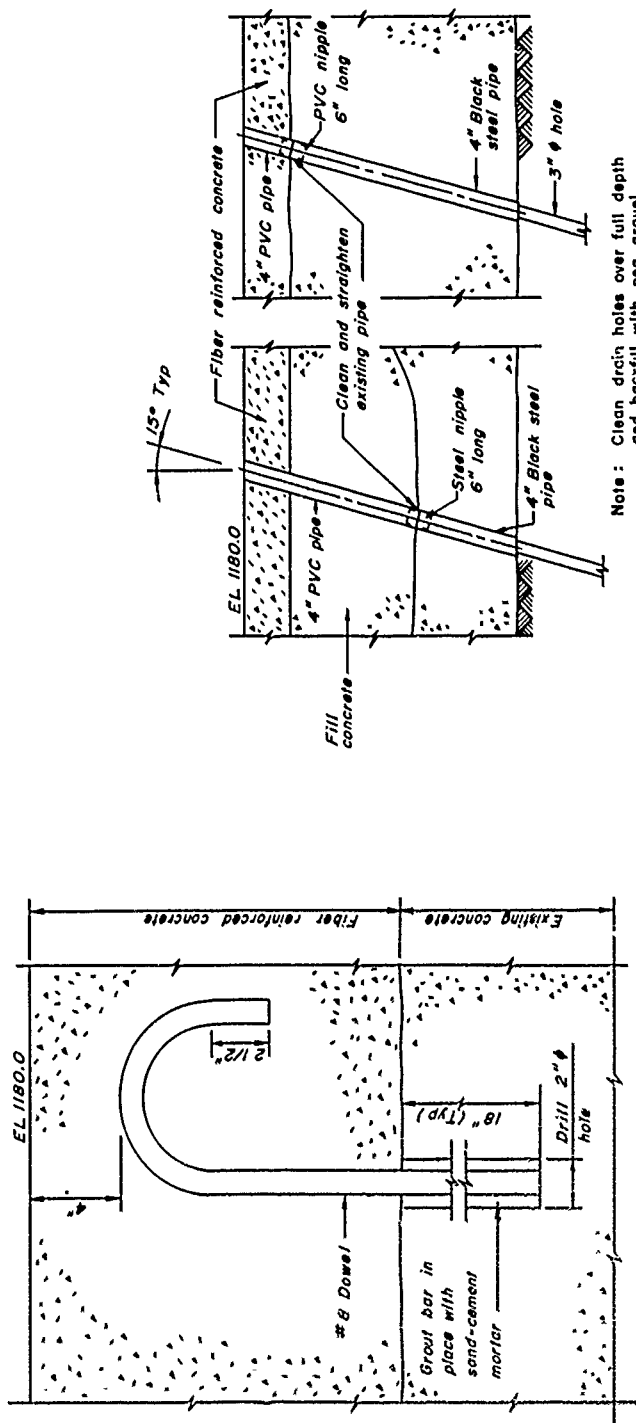
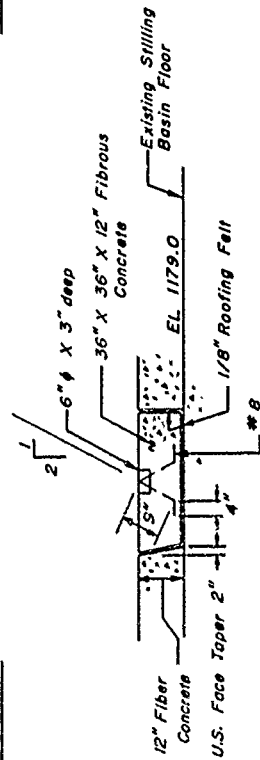
Figure 144. Stilling basin repair details, Kinzua Dam

Note: Clean drain holes over full depth and backfill with pea gravel.
